## CHINA TOILET BOWL LEAKING WATER

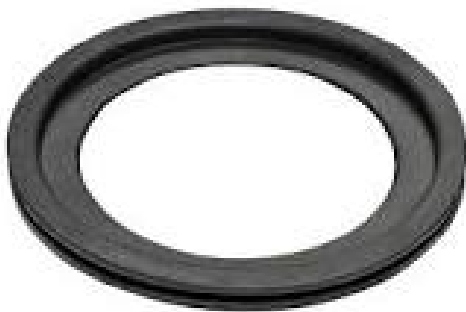
1. What is it? Toilet Flush Valve Seal
2. Symptoms or Problem? Toilet bowl water level drops or odors from tank
3. Location: Just below bowl when flush ball valve open
4. Replacement Availability: For Dometic 310 Series or Sealand Traveler Toilet Flush Valve Seal Part# 385311658 – Amazon or any RV parts dealer
5. Ease of Replacement: DIY; Directions included with part but the flush valve will need to remain open. Turn water off. Removing seal easy, replacing takes some patience. Most importantly CLEAN the rim where seal was positioned before replacing. Build-up will cause it to leak. Try cleaning and replacing original seal if in good condition as it may resolve the issue and you'll have a spare just in case! Recommend using a product like Thetford Toilet Seal Conditioner.
